ERDC/CERL TR-01-11

## **Structural Evaluation of Aircraft Hangar 46, Corpus Christi Army Depot**

Ghassan K. Al-Chaar, Daniel J. Randolph,  
Gregory E. Lamb, and Pramod J. Desai

February 2001

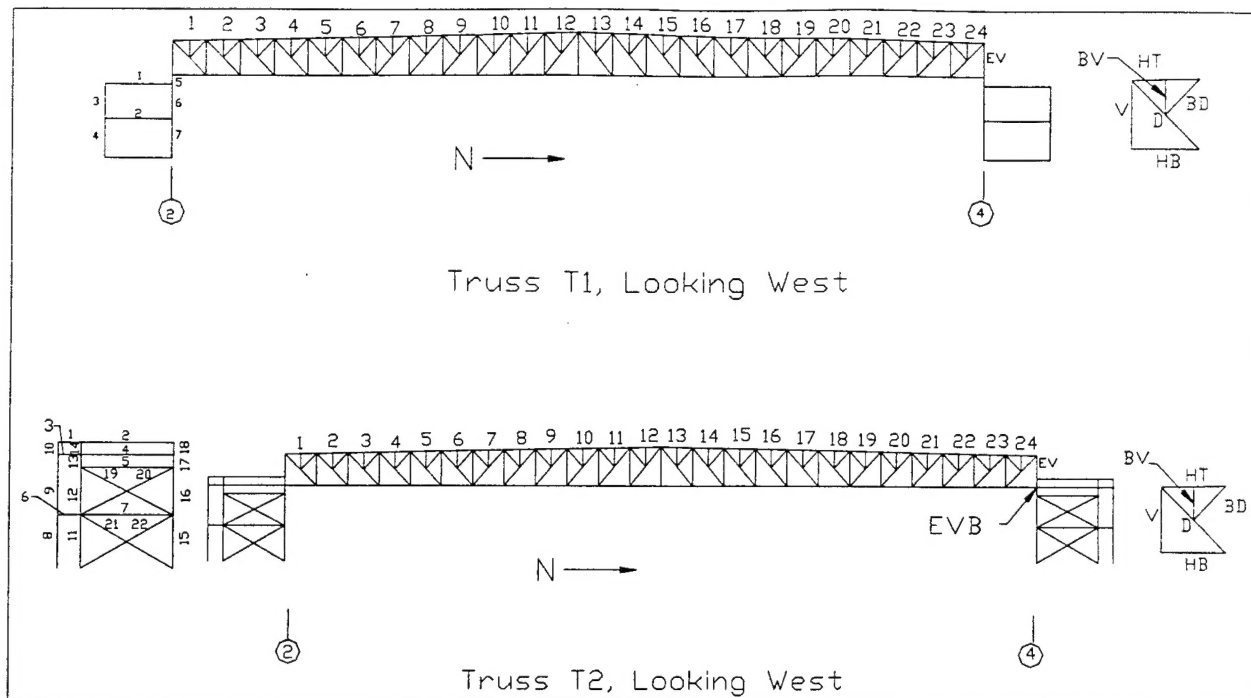
Figure 2-1. Truss T1 and T2 identification numbers.

Five types of trusses were identified in Hangar 46, as shown in Figures 2-1 and 2-2. Every member was labeled for each type of truss, and can be located by defining the hangar number, truss type number, truss location on the plan drawing, section of the truss, and a unique identifying label. Photographs of damaged members and other hangar elements may be found in Appendix A, and supplementary diagrams are shown in Appendix B.

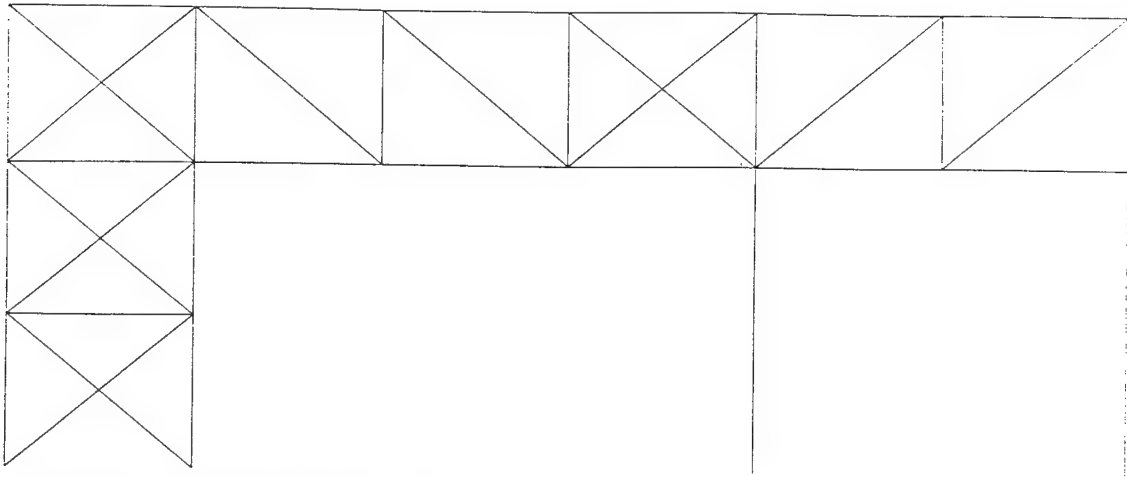
Figure B-6. Truss T3 with retrofit column included.

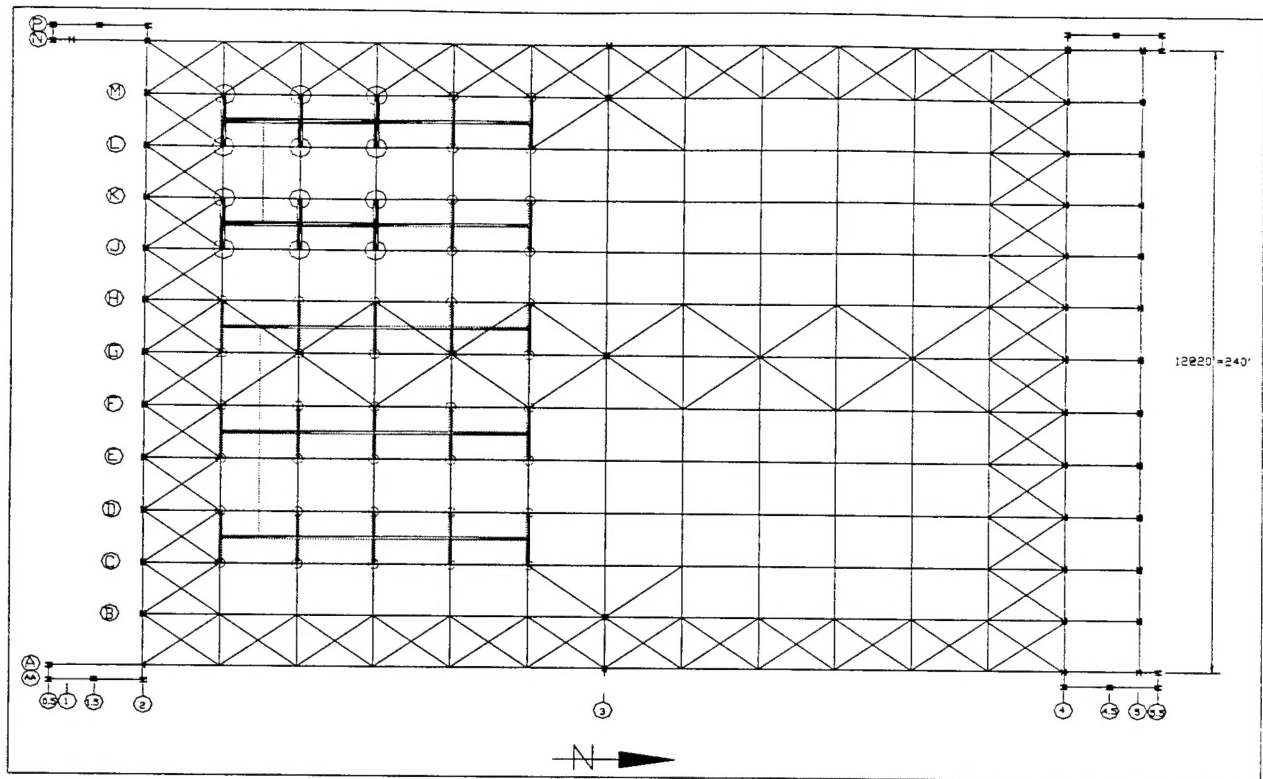
Attached as Appendix C is a memorandum pertaining to the crane installation in Hangar 46, including a diagram of the current and proposed crane locations and a photograph of the current system in Hangar 46. It was submitted by the project team's structural engineer as an initial opinion on the safety of expanding the crane system. The recommendations were based on the assumption that the existing crane system is safe according to current codes. However, after structural analysis it was determined that Hangar 46 requires some structural rehabilitation because the old crane system puts stresses on trusses T1 and T3 that exceed AISC ASD 89 allowable limits. Therefore, retrofit as proposed in Chapter 8 is necessary.

Figure C-1. Location of current and proposed railway crane.

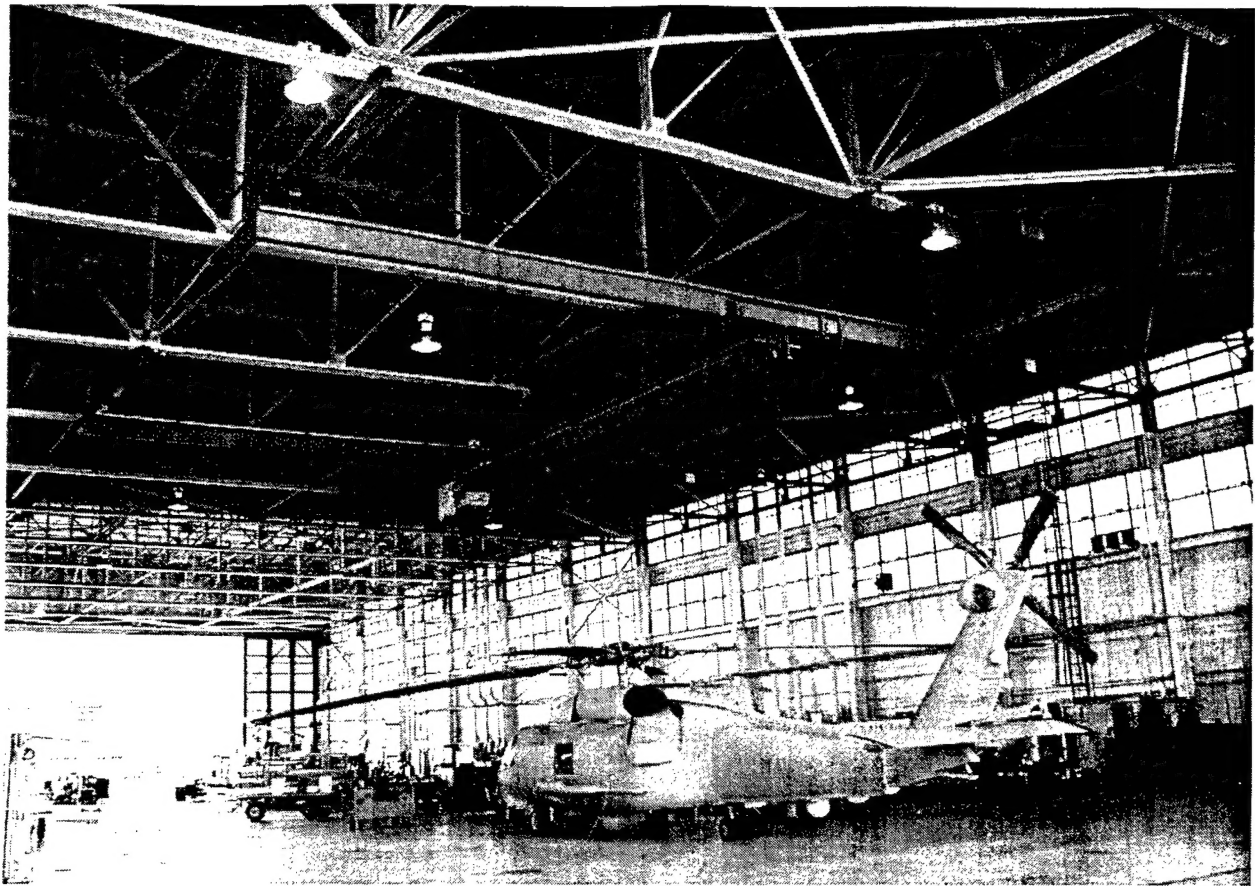
Figure C-2. Ten thousand pound capacity crane in Hangar 46.
